MUBAYA WEIR CONSTRUCTION REPORT

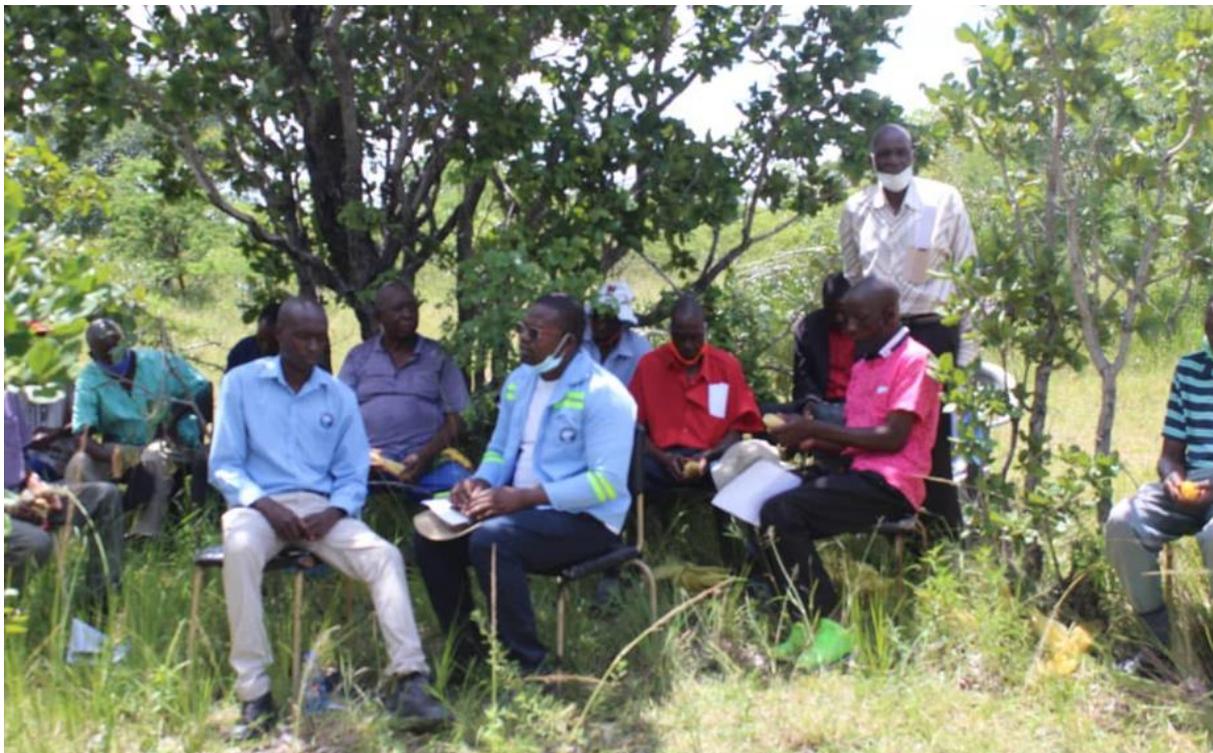
Plate 1: Stakeholder's meeting held at the Weir Dam site

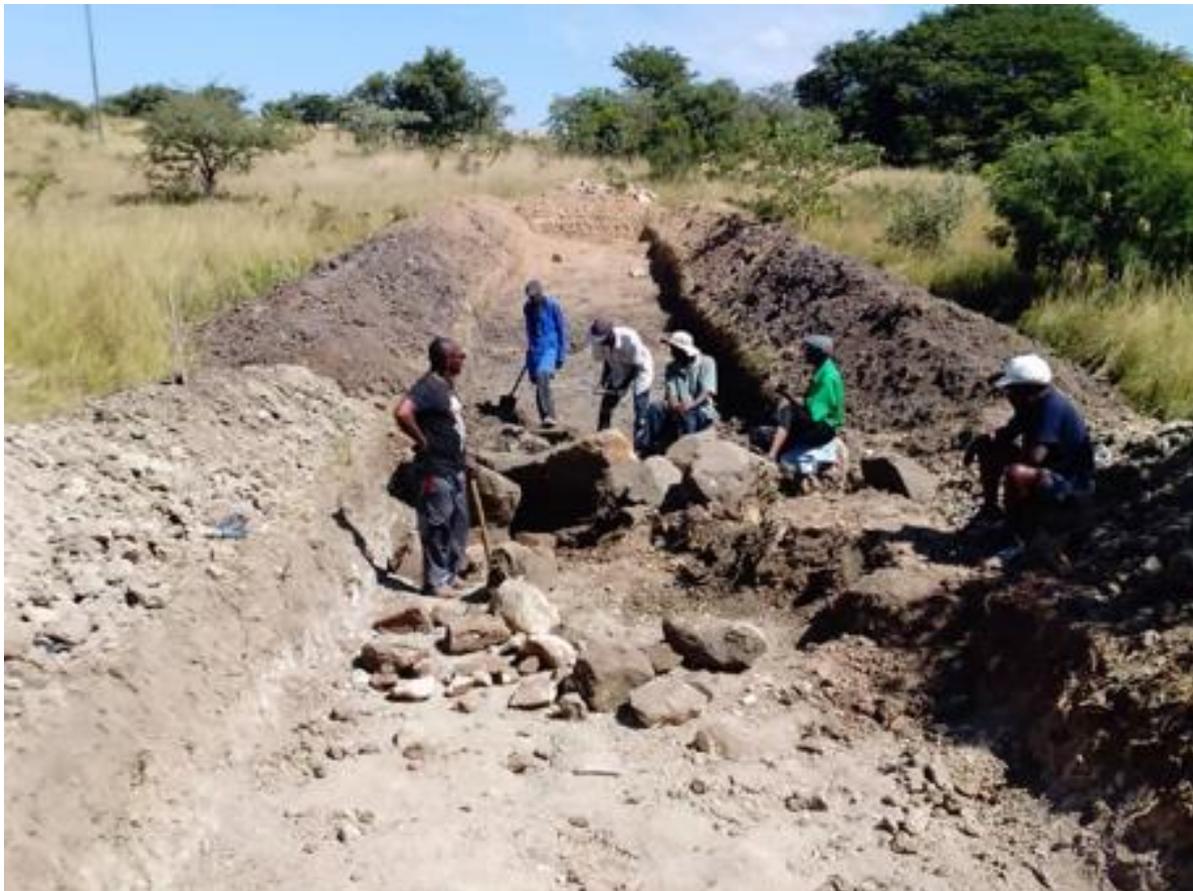
Plate 2: Villagers digging the weir foundation.

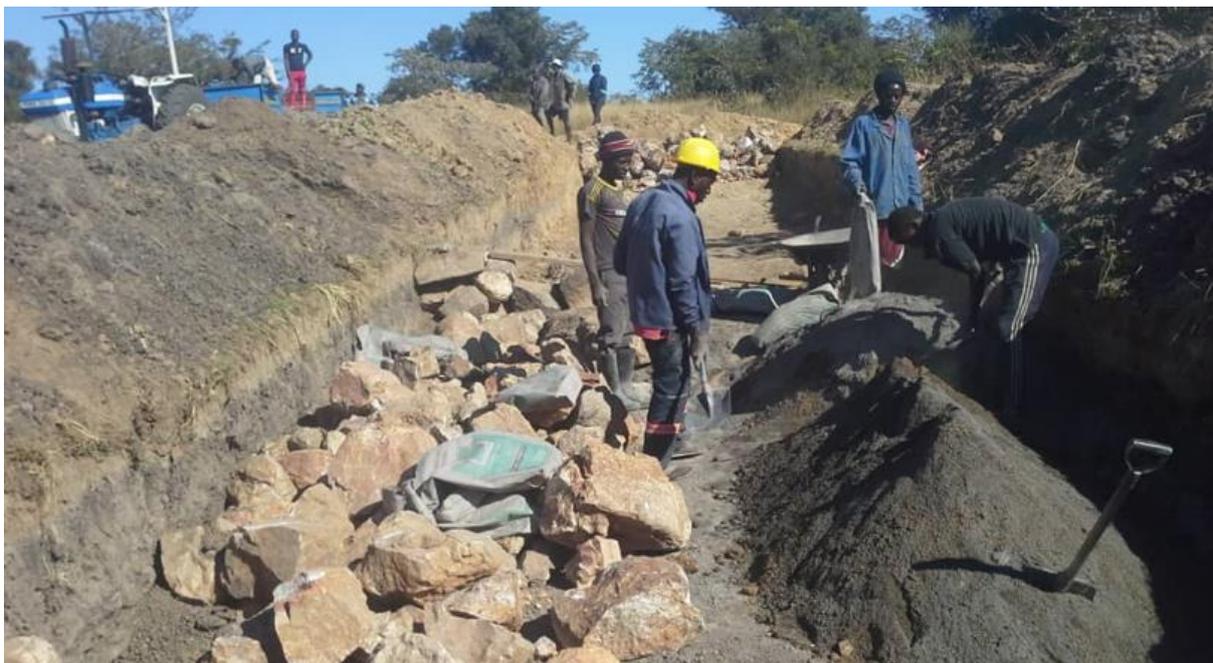
Plate 4: Weir Dam construction in progress

1. Cut off trench excavated to firm sub soil. No hard excavation.
2. Core material from upstream areas
3. Fill material primarily from the dam basin

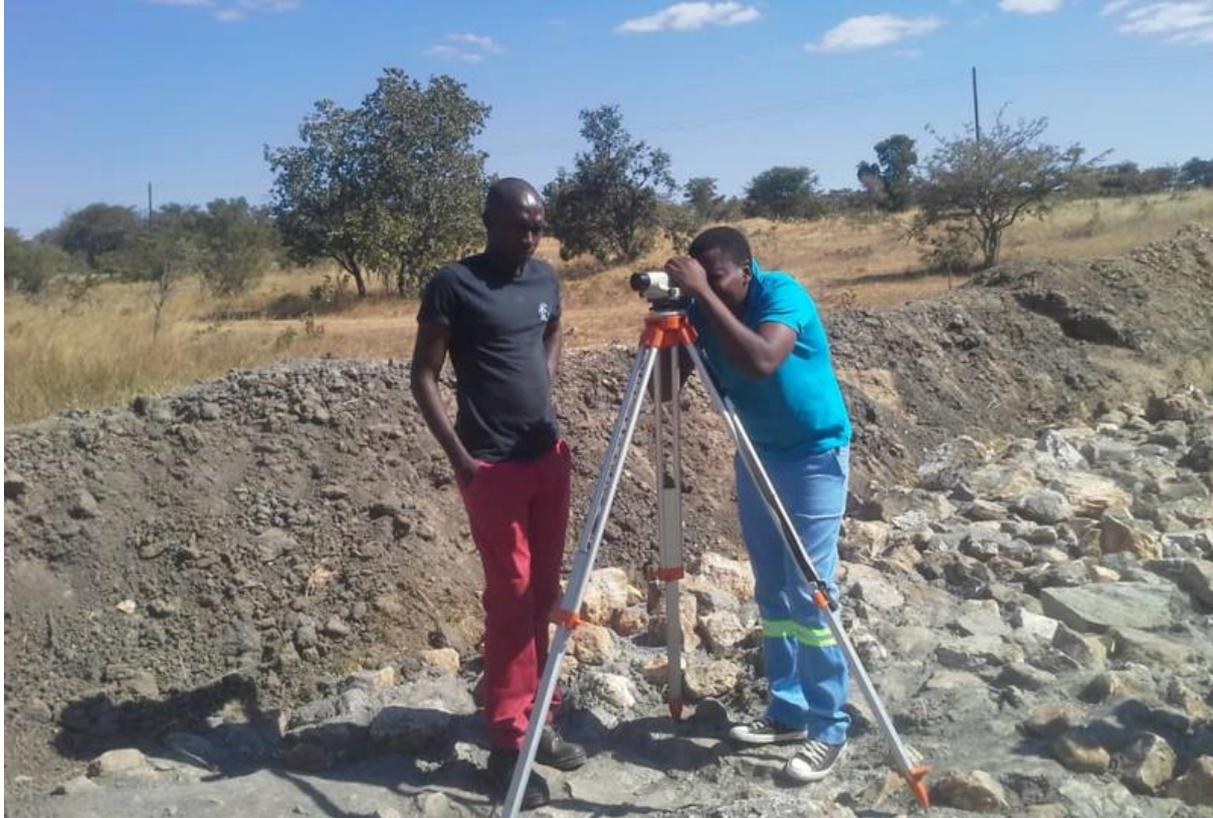
Plate 5: Middle Manyame Sub-catchment personnel taking levels
